Checklist for Stormwater Report

TABLE 1: ORIGINAL, EXISTING & PROPOSED CONDITIONS - PEAK RUNOFF RATES & TOTAL RUNOFF VOLUMES
1089 Millbury Street - Worcester, Massachusetts

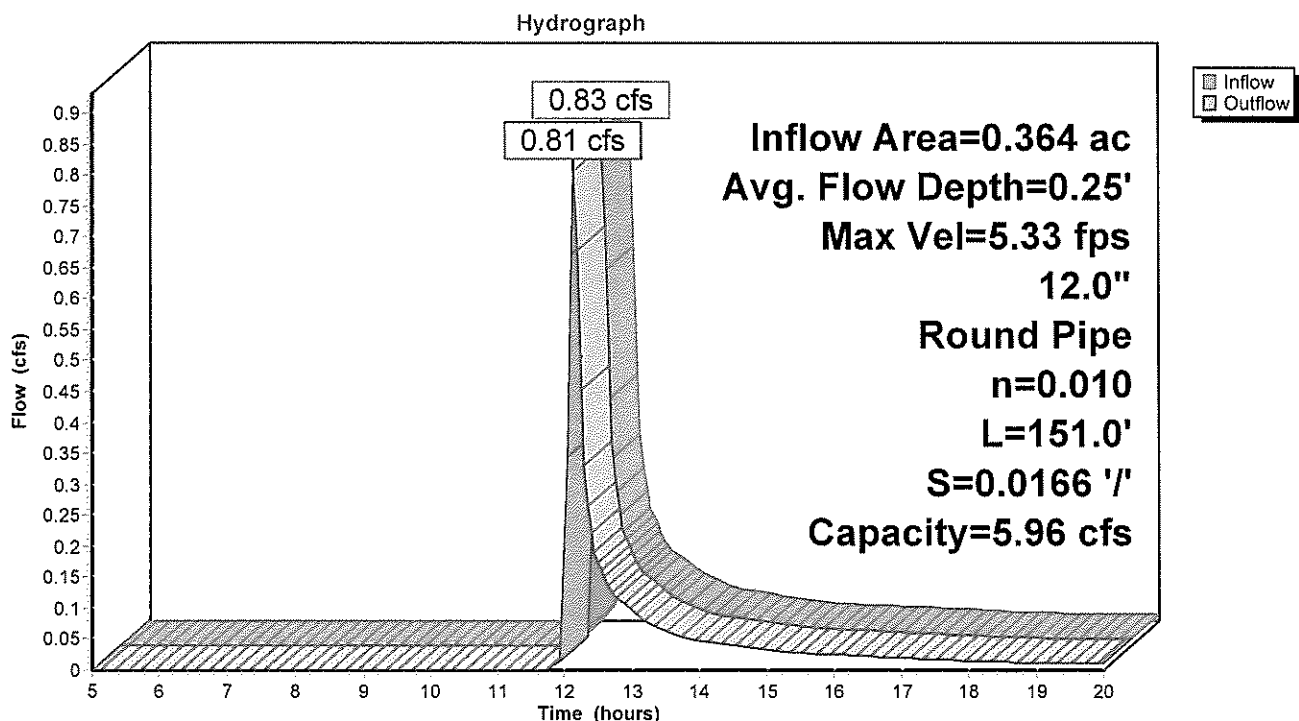
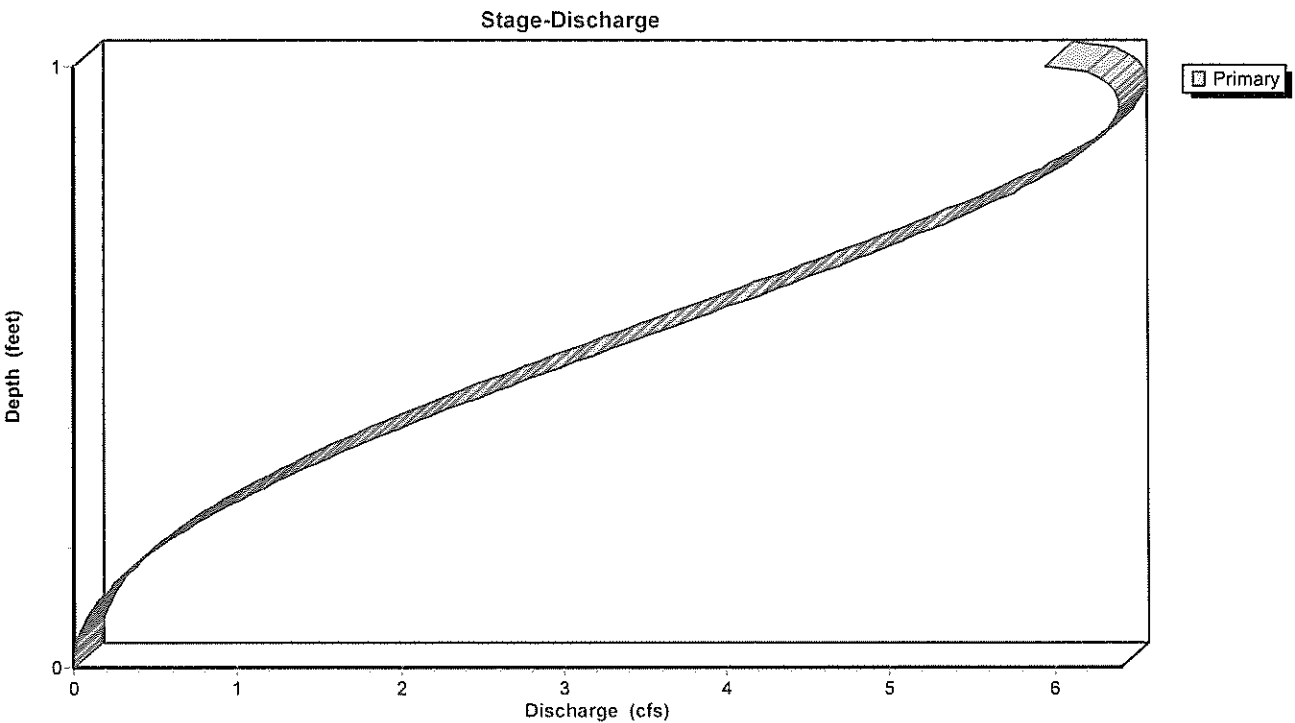
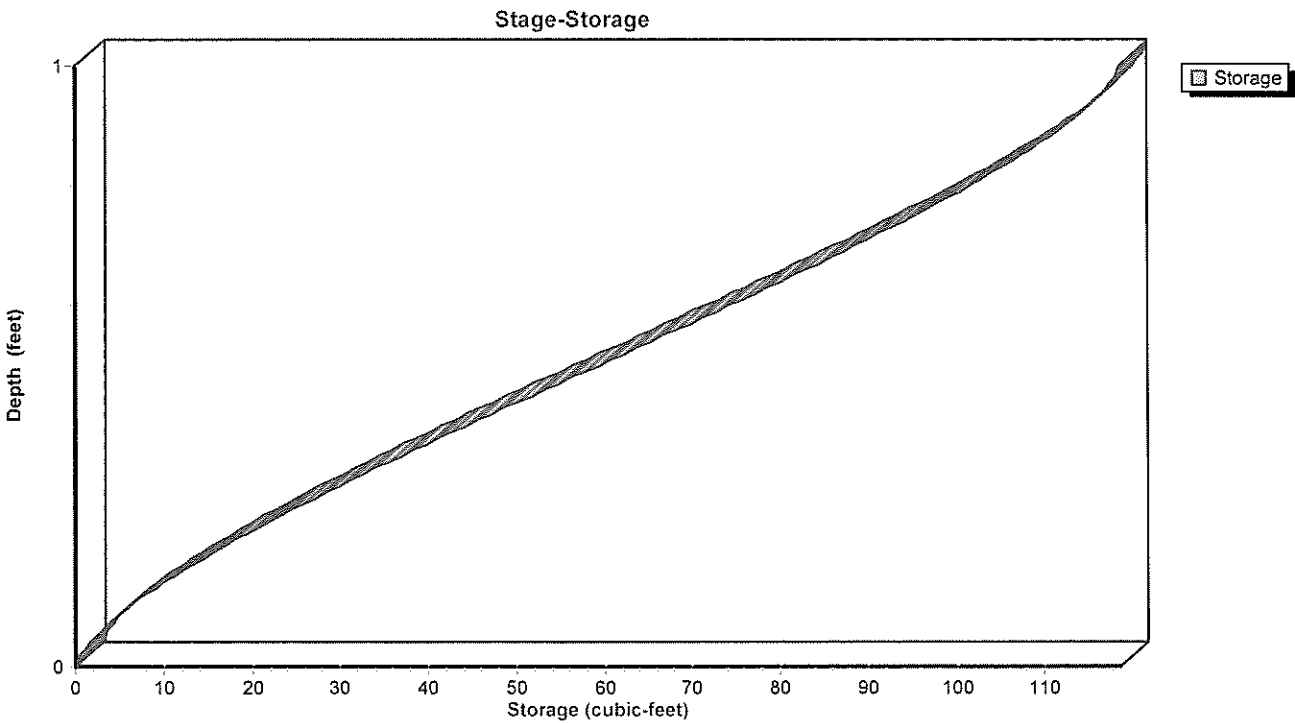
Summary for Reach DL: 12" D PVC Drail Line to CB2 in Millbury Street & Municipal Sewer

Inflow Area = 0.364 ac, 0.00% Impervious, Inflow Depth > 1.28" for 10-Year event
 Inflow = 0.83 cfs @ 12.14 hrs, Volume= 0.039 af
 Outflow = 0.81 cfs @ 12.15 hrs, Volume= 0.039 af, Atten= 3%, Lag= 0.7 min
 Routed to Link CB3 : Design Point - Municipal Catch Basin in Millbury Street

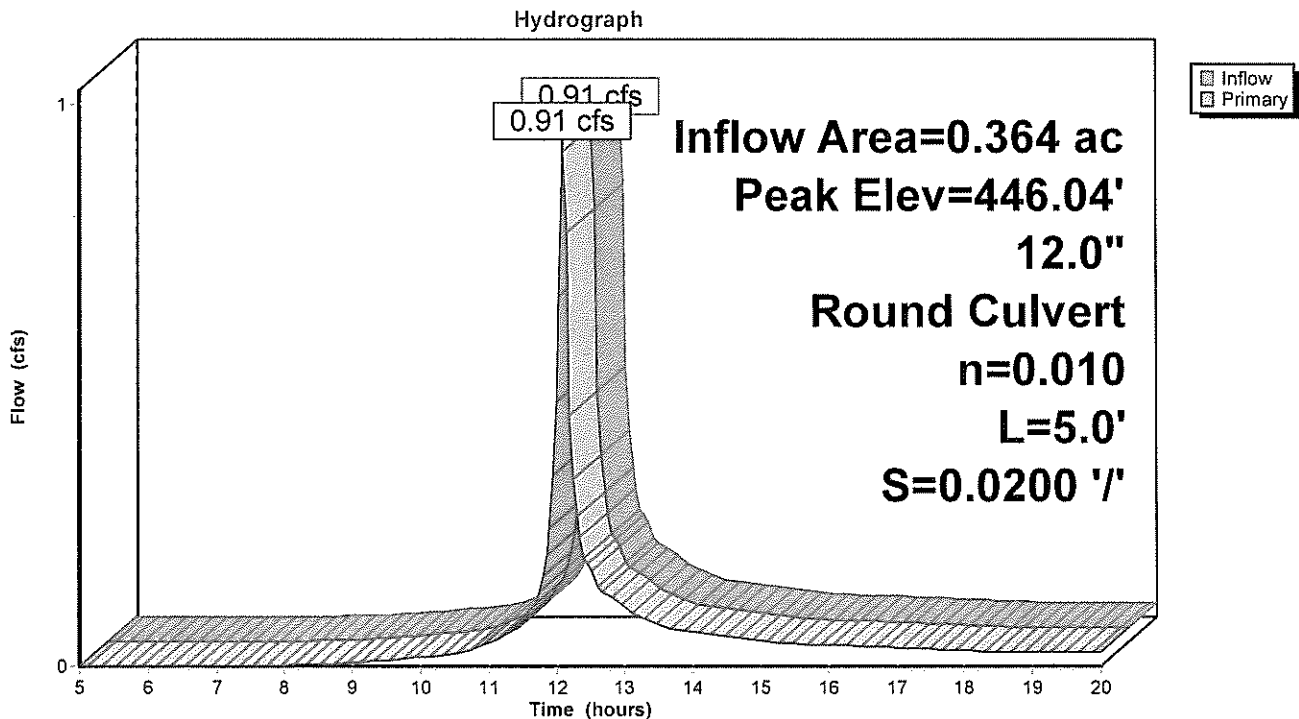
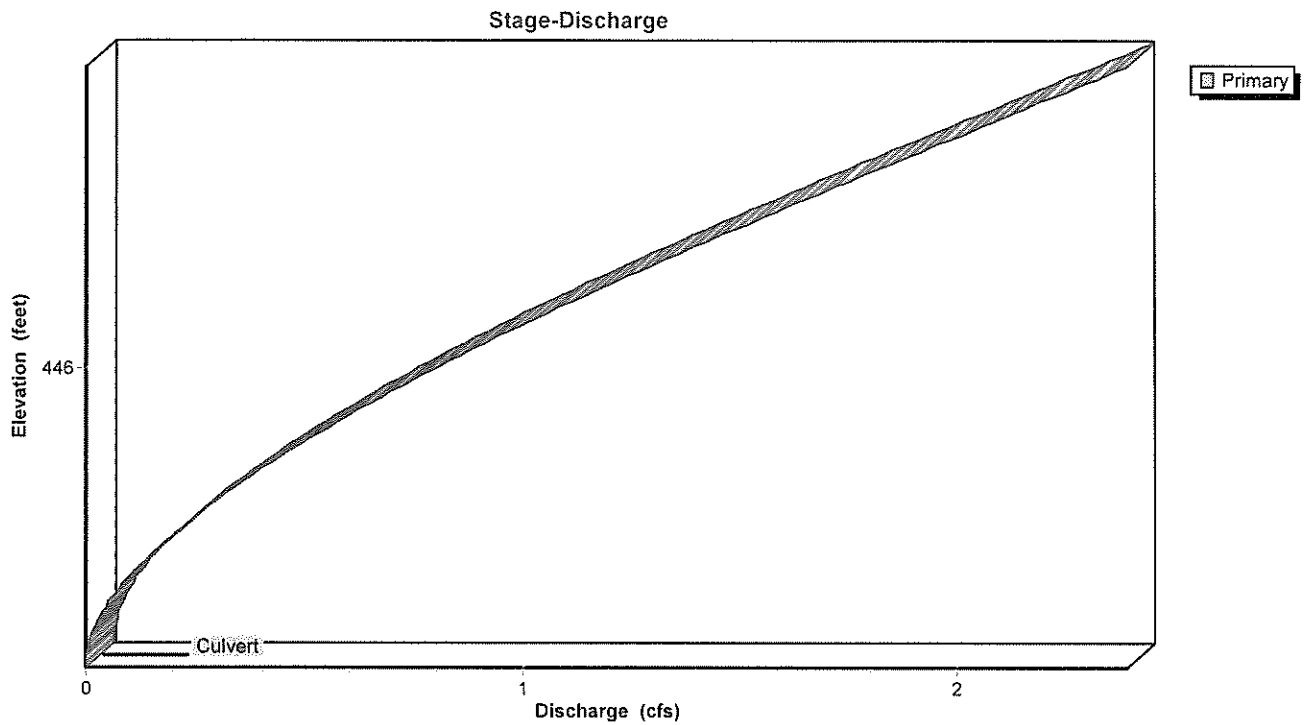
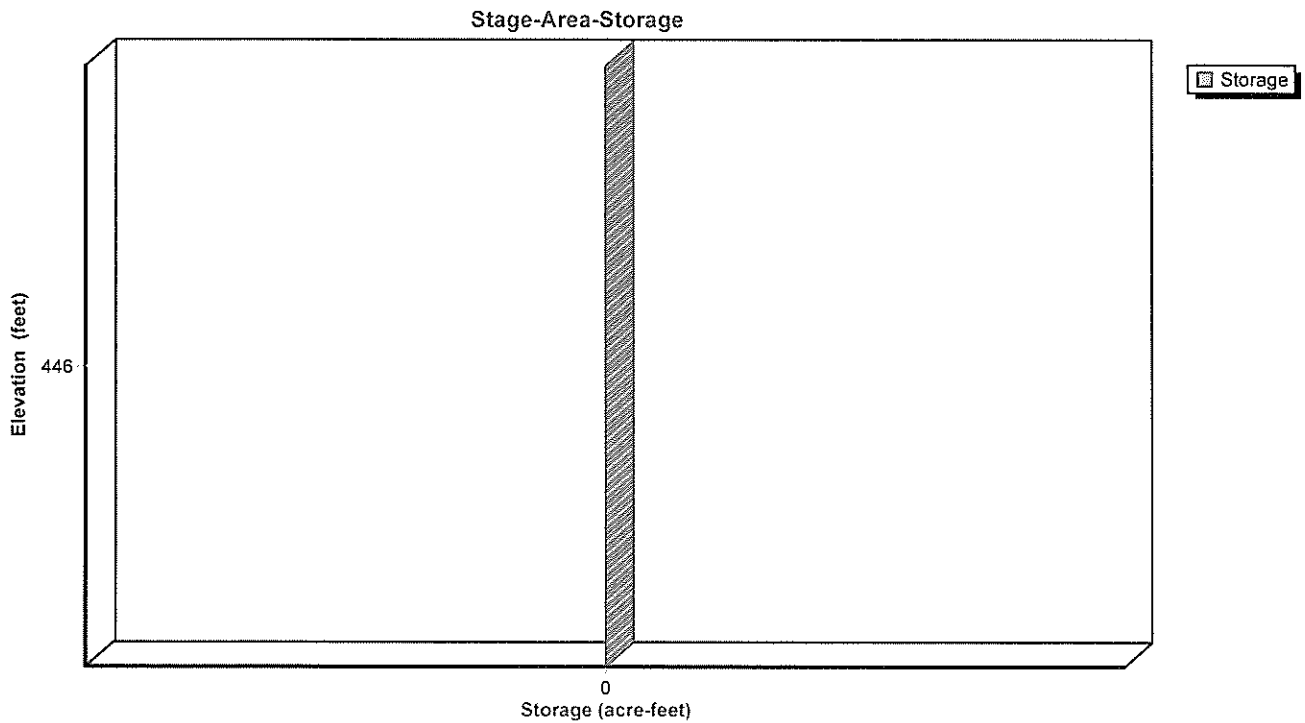
Summary for Pond CB1: Catch Basin 1

Inflow Area = 0.364 ac, 0.00% Impervious, Inflow Depth > 1.95" for 10-Year event
 Inflow = 0.91 cfs @ 12.11 hrs, Volume= 0.059 af
 Outflow = 0.91 cfs @ 12.11 hrs, Volume= 0.059 af, Atten= 0%, Lag= 0.0 min
 Primary = 0.91 cfs @ 12.11 hrs, Volume= 0.059 af
 Routed to Pond IT : Interceptor?Recharge Trench

Primary OutFlow Max=0.89 cfs @ 12.11 hrs HW=446.03' (Free Discharge)
 1=Culvert (Barrel Controls 0.89 cfs @ 3.05 fps)

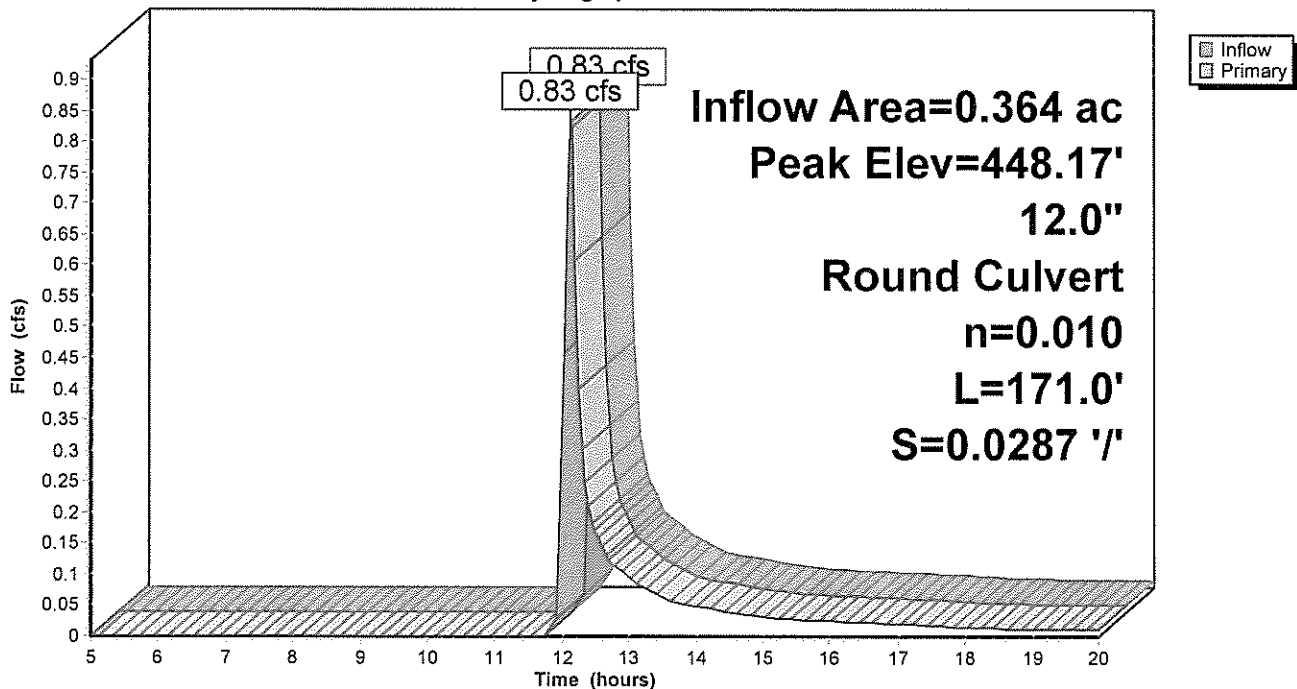
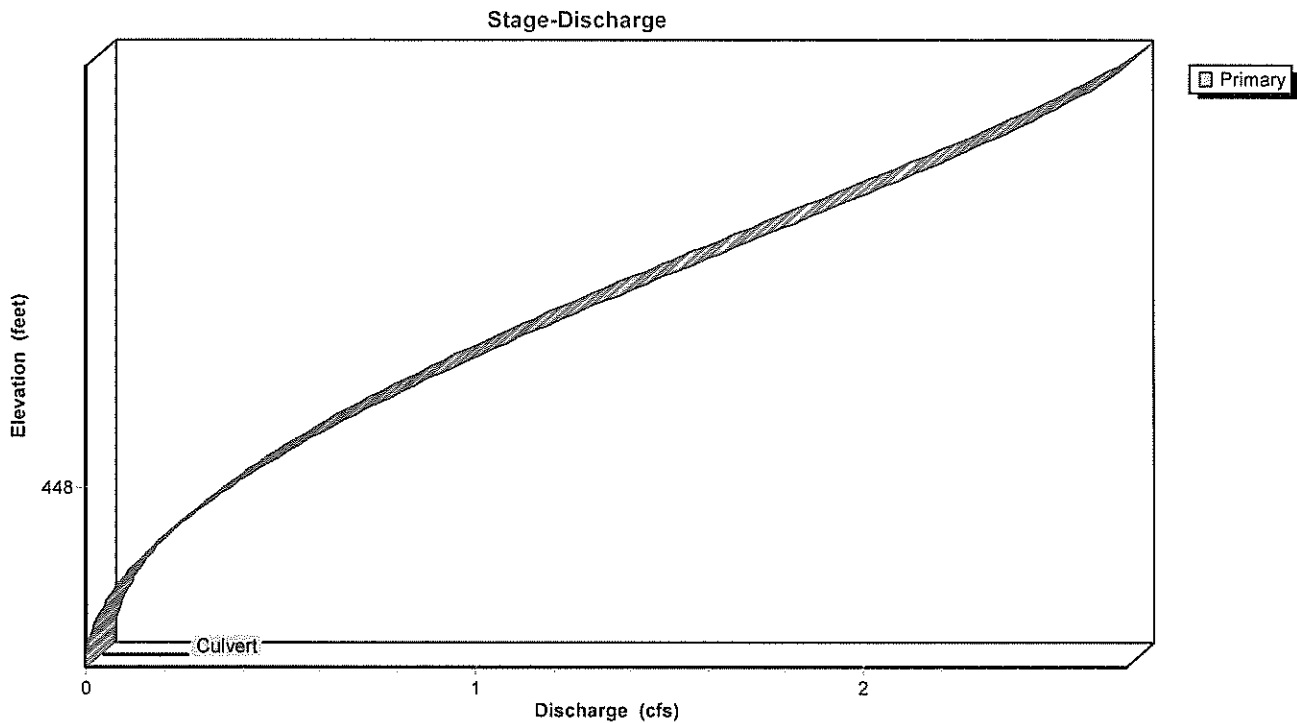
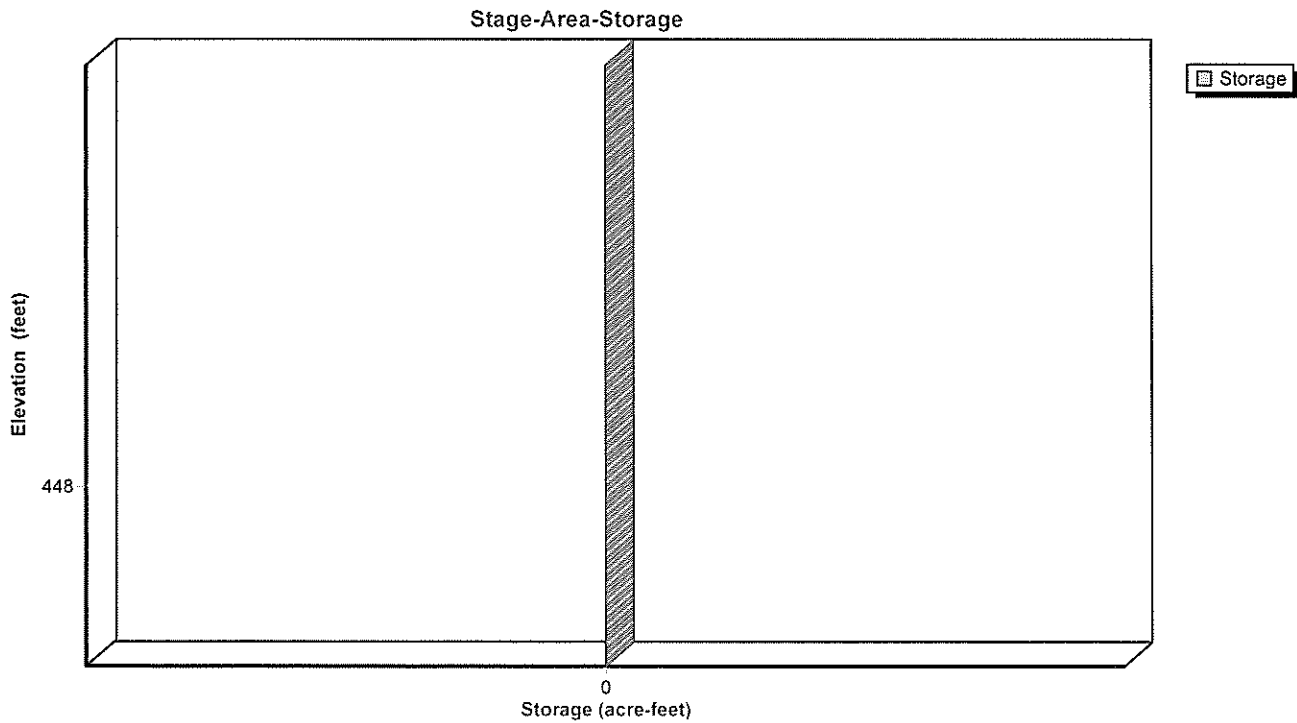
Summary for Pond CB2: Catch Basin

Inflow Area = 0.364 ac, 0.00% Impervious, Inflow Depth > 1.28" for 10-Year event
 Inflow = 0.83 cfs @ 12.14 hrs, Volume= 0.039 af
 Outflow = 0.83 cfs @ 12.14 hrs, Volume= 0.039 af, Atten= 0%, Lag= 0.0 min
 Primary = 0.83 cfs @ 12.14 hrs, Volume= 0.039 af
 Routed to Reach DL : 12" D PVC Drail Line to CB2 in Millbury Street & Municipal Sewer

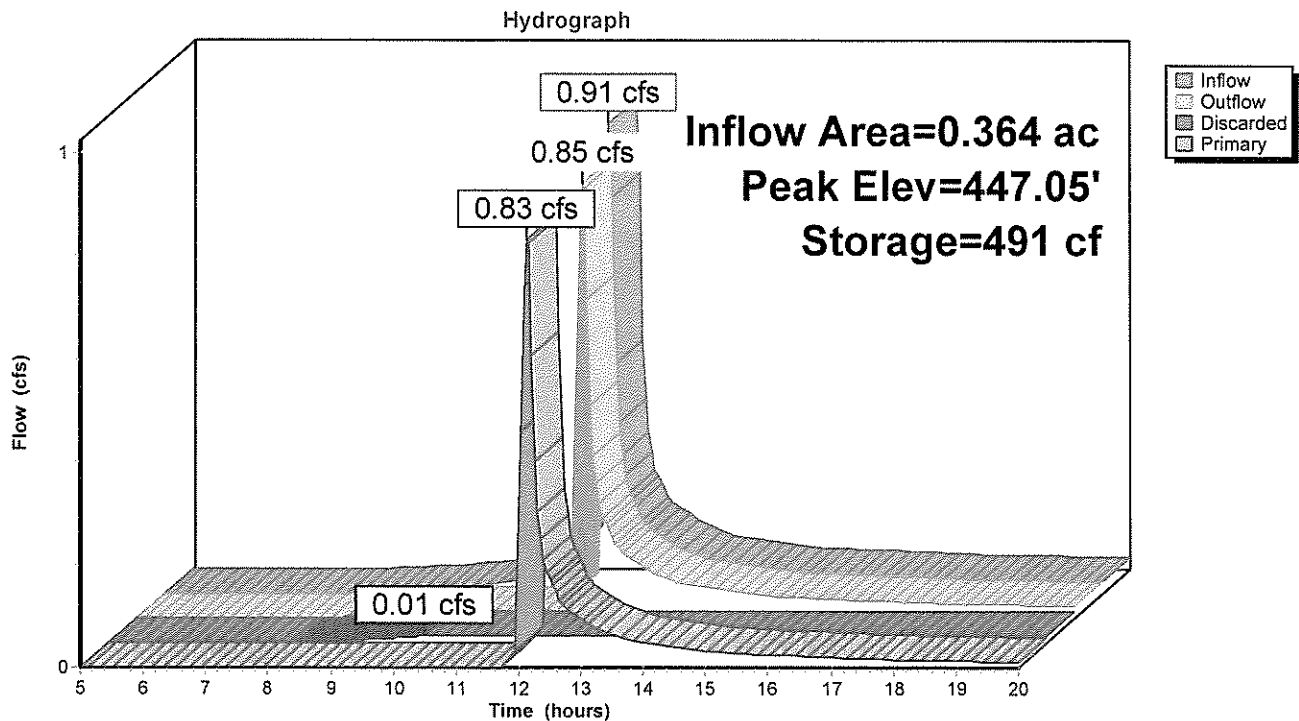
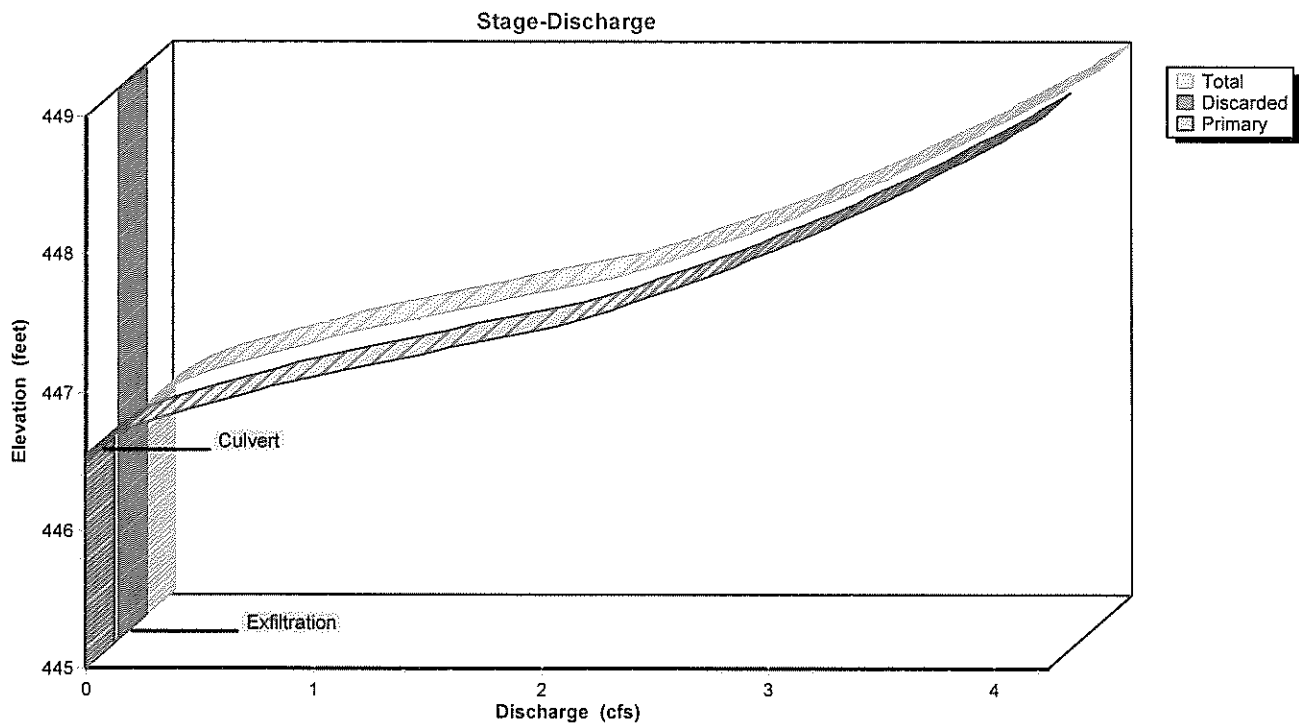
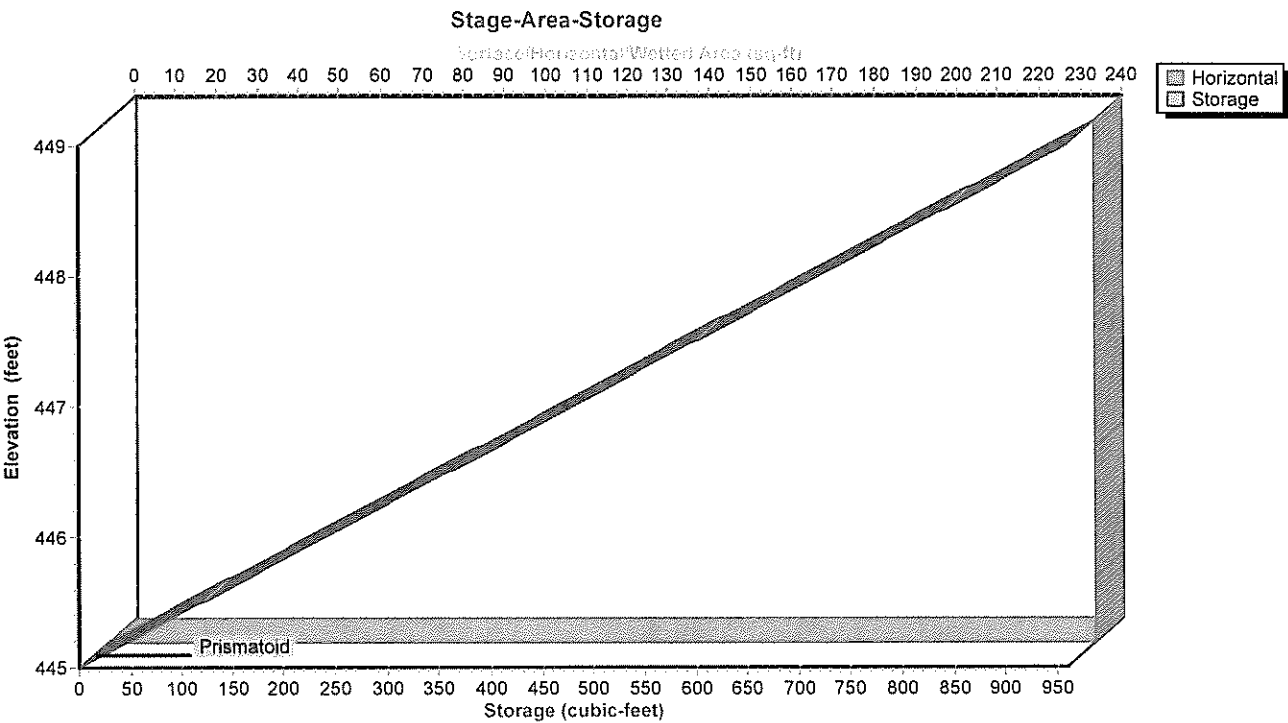
Summary for Pond IT: Interceptor?Recharge Trench

Inflow Area = 0.364 ac, 0.00% Impervious, Inflow Depth > 1.95" for 10-Year event
 Inflow = 0.91 cfs @ 12.11 hrs, Volume= 0.059 af
 Outflow = 0.85 cfs @ 12.14 hrs, Volume= 0.051 af, Atten= 8%, Lag= 1.9 min
 Discarded = 0.01 cfs @ 10.05 hrs, Volume= 0.012 af
 Primary = 0.83 cfs @ 12.14 hrs, Volume= 0.039 af
 Routed to Pond CB2 : Catch Basin

Primary OutFlow Max=0.81 cfs @ 12.14 hrs HW=447.03' (Free Discharge)
 ↗2=Culvert (Barrel Controls 0.81 cfs @ 2.73 fps)

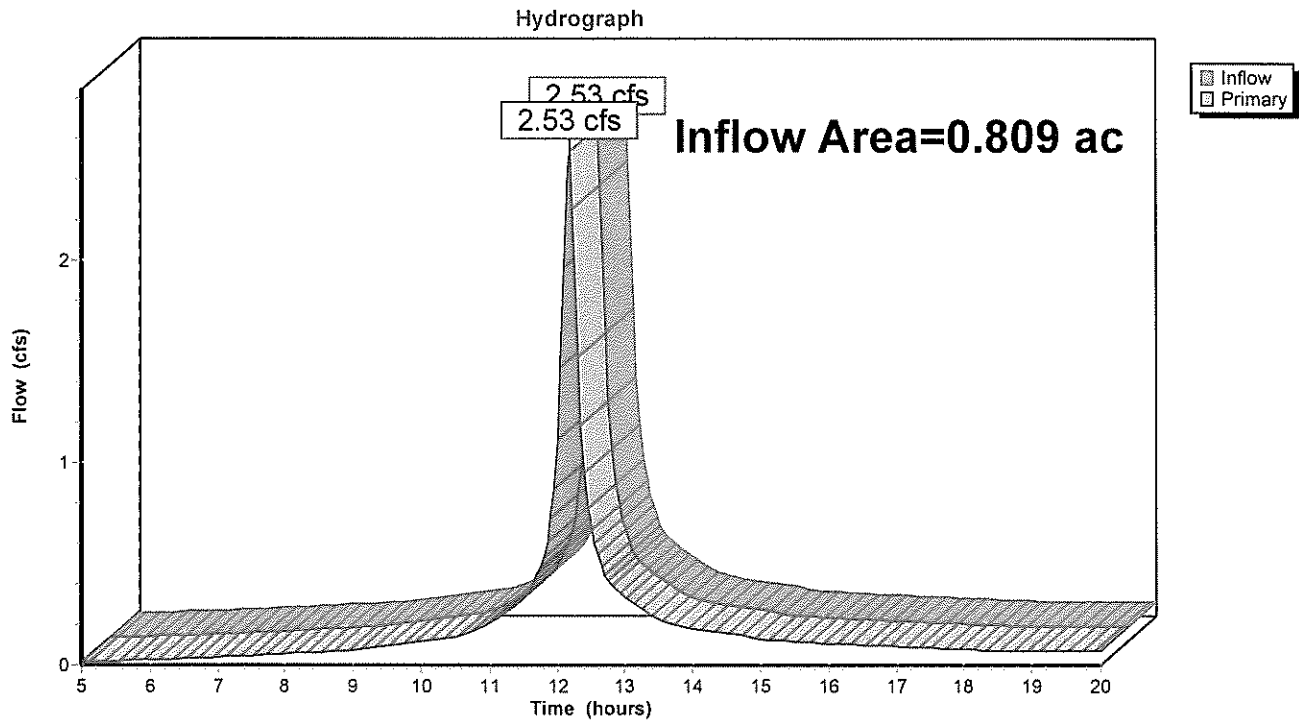
Summary for Link C-M.S.: Design Point - Current Conditions - Millbury Street

Inflow Area = 0.809 ac, 11.27% Impervious, Inflow Depth > 3.25" for 10-Year event
 Inflow = 2.53 cfs @ 12.18 hrs, Volume= 0.219 af
 Primary = 2.53 cfs @ 12.18 hrs, Volume= 0.219 af, Atten= 0%, Lag= 0.0 min

Primary outflow = Inflow, Time Span= 5.00-20.00 hrs, dt= 0.05 hrs

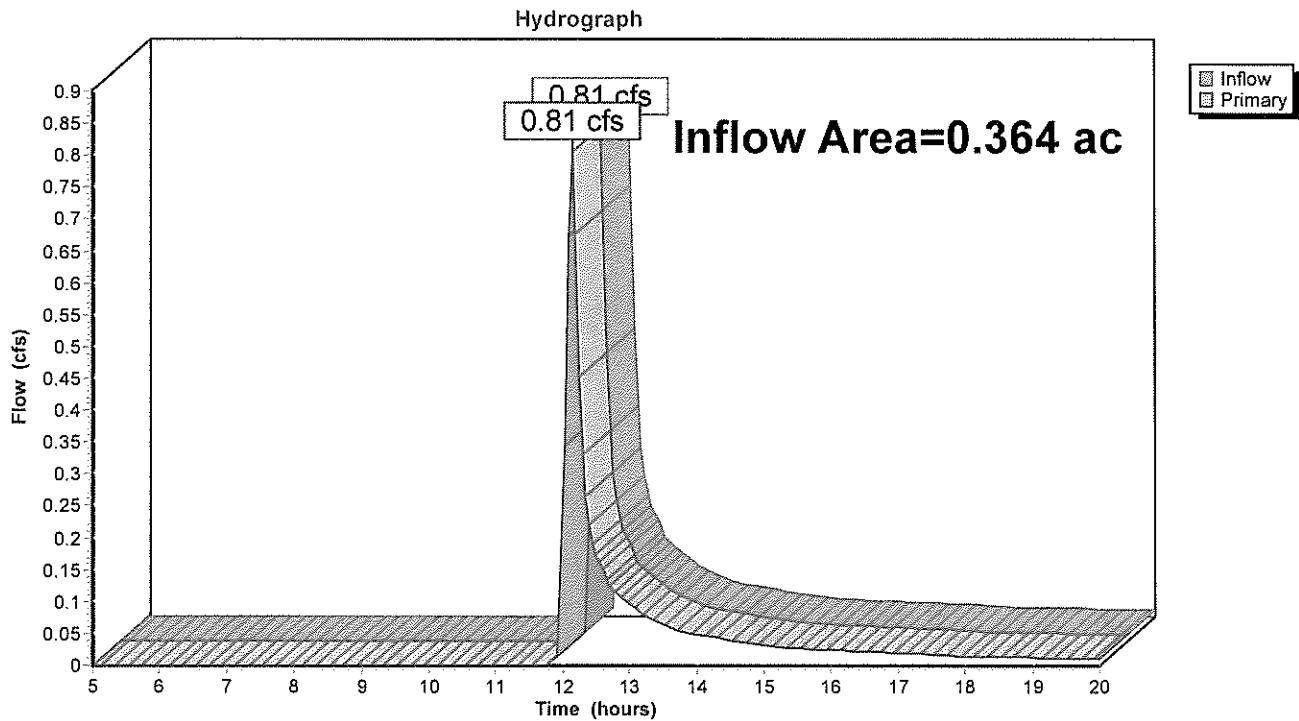
Summary for Link CB3: Design Point - Municipal Catch Basin in Millbury Street

Inflow Area = 0.364 ac, 0.00% Impervious, Inflow Depth > 1.27" for 10-Year event
 Inflow = 0.81 cfs @ 12.15 hrs, Volume= 0.039 af
 Primary = 0.81 cfs @ 12.15 hrs, Volume= 0.039 af, Atten= 0%, Lag= 0.0 min

Primary outflow = Inflow, Time Span= 5.00-20.00 hrs, dt= 0.05 hrs

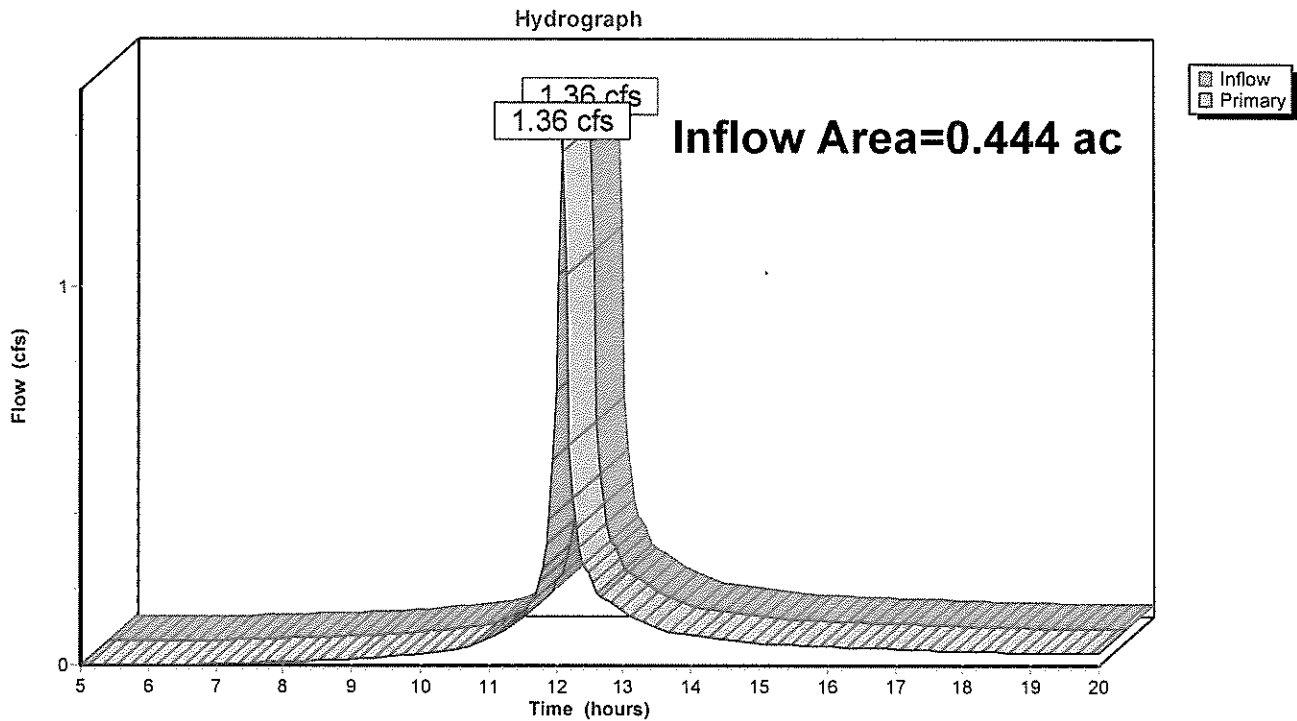
Summary for Link MS: Design Point - Millbury Street

Inflow Area = 0.444 ac, 20.50% Impervious, Inflow Depth > 2.36" for 10-Year event
 Inflow = 1.36 cfs @ 12.10 hrs, Volume= 0.087 af
 Primary = 1.36 cfs @ 12.10 hrs, Volume= 0.087 af, Atten= 0%, Lag= 0.0 min

Primary outflow = Inflow, Time Span= 5.00-20.00 hrs, dt= 0.05 hrs

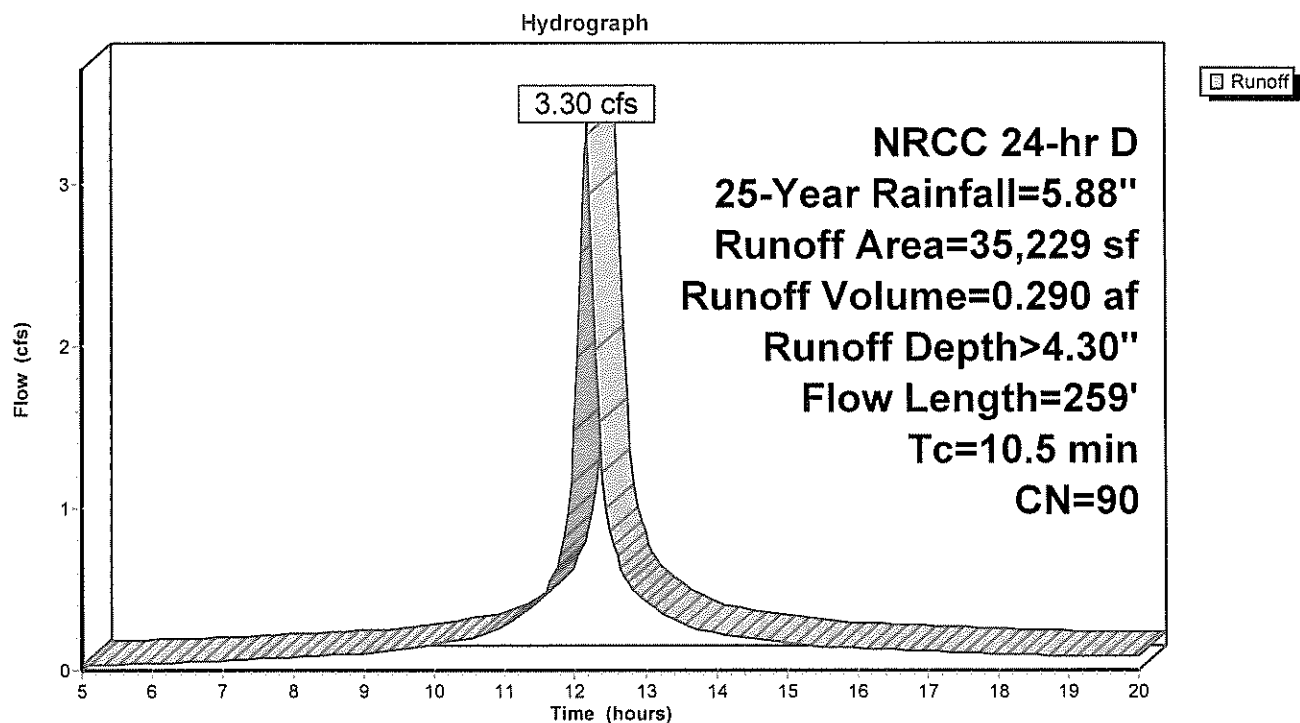
Subcatchment 1089: Current 2020 Conditions 1087-1089 Millbury St. TOTAL LOT

Tc (min)	Length (feet)	Slope (ft/ft)	Velocity (ft/sec)	Capacity (cfs)	Description
9.8	32	0.0600	0.05		Sheet Flow, Sheet Flow Woods: Dense underbrush n= 0.800 P2= 3.13"
0.1	73	0.4500	10.80		Shallow Concentrated Flow, Shallow Concentrated Unpaved Kv= 16.1 fps
0.6	154	0.0840	4.67		Shallow Concentrated Flow, Shallo Concentrated Unpaved Kv= 16.1 fps
10.5	259	Total

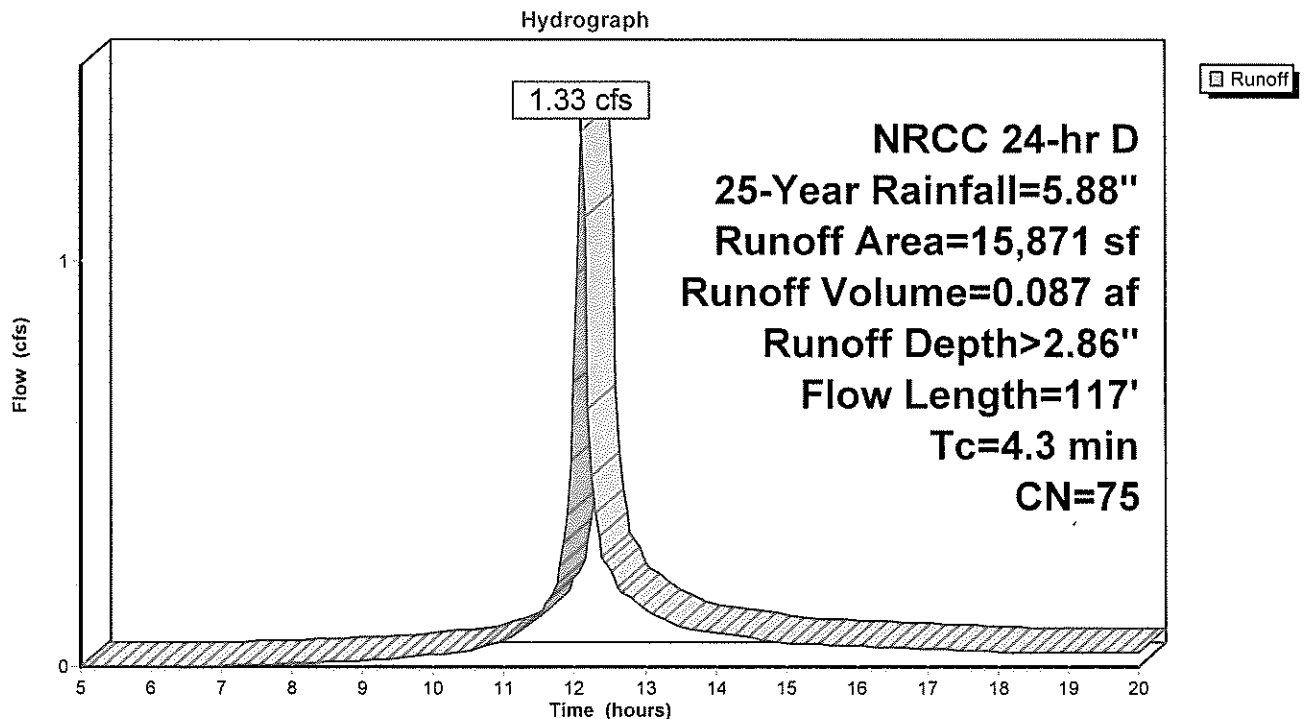
Subcatchment P-A: Poposed 2021 Conditions 1087-1089 Millbury St. Upper Section to Drain Syst

ary for Subcatchment P-A: Poposed 2021 Conditions 1087-1089 Millbury St. Upper Section to Dra

Runoff = 1.33 cfs @ 12.11 hrs, Volume= 0.087 af, Depth> 2.86"
 Routed to Pond CB1 : Catch Basin 1

Tc (min)	Length (feet)	Slope (ft/ft)	Velocity (ft/sec)	Capacity (cfs)	Description
2.4	10	0.2000	0.07		Sheet Flow, Sheet Flow-1 Trees Woods: Dense underbrush n= 0.800 P2= 3.13"
1.6	40	0.3000	0.41		Sheet Flow, Sheet Flow 2 - Grass Grass: Short n= 0.150 P2= 3.13"
0.3	67	0.3000	3.83		Shallow Concentrated Flow, Shallow Concentrated Short Grass Pasture Kv= 7.0 fps
4.3	117	Total

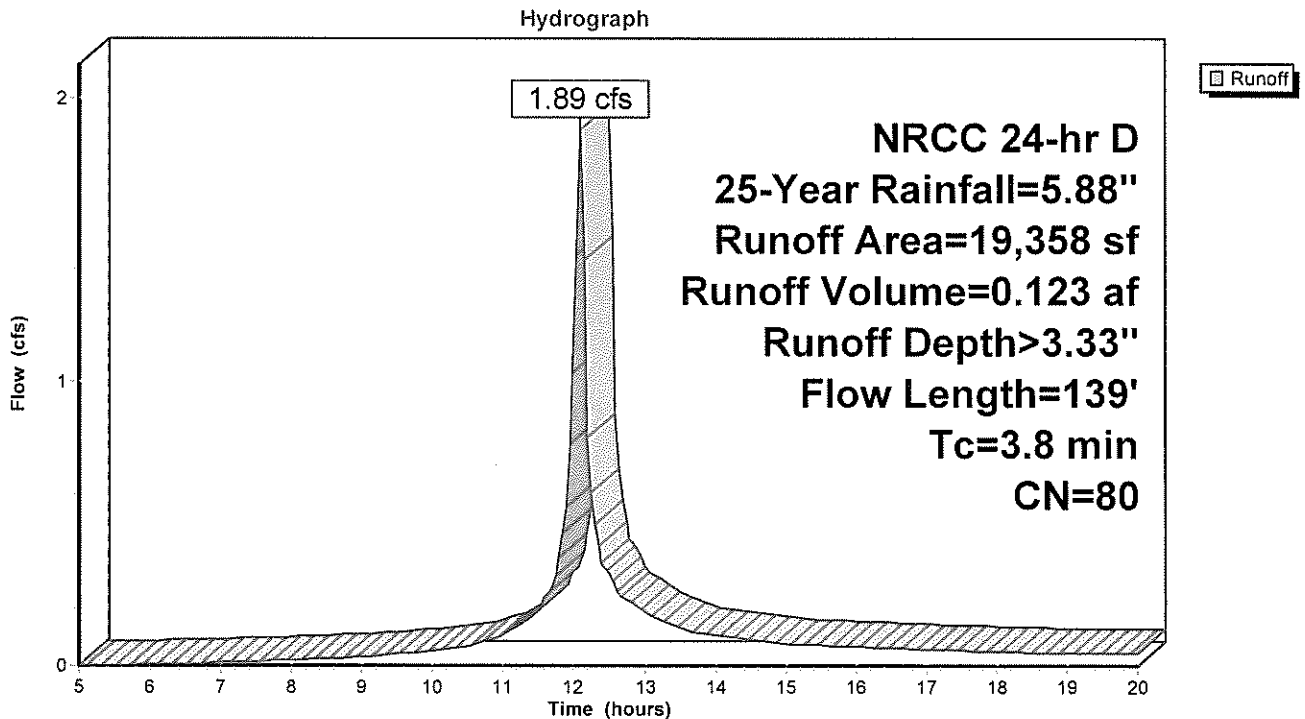
Hydrograph for Subcatchment P-B: Poposed 2021 Conditions 1087-1089 Millbury St. Lower Section To Millbury St

Tc (min)	Length (feet)	Slope (ft/ft)	Velocity (ft/sec)	Capacity (cfs)	Description
3.0	50	0.1000	0.28		Sheet Flow, Sheet Flow - Grass
					Grass: Short n= 0.150 P2= 3.13"
0.8	89	0.0700	1.85		Shallow Concentrated Flow, Shallow Concentrated
					Short Grass Pasture Kv= 7.0 fps
3.8	139	Total

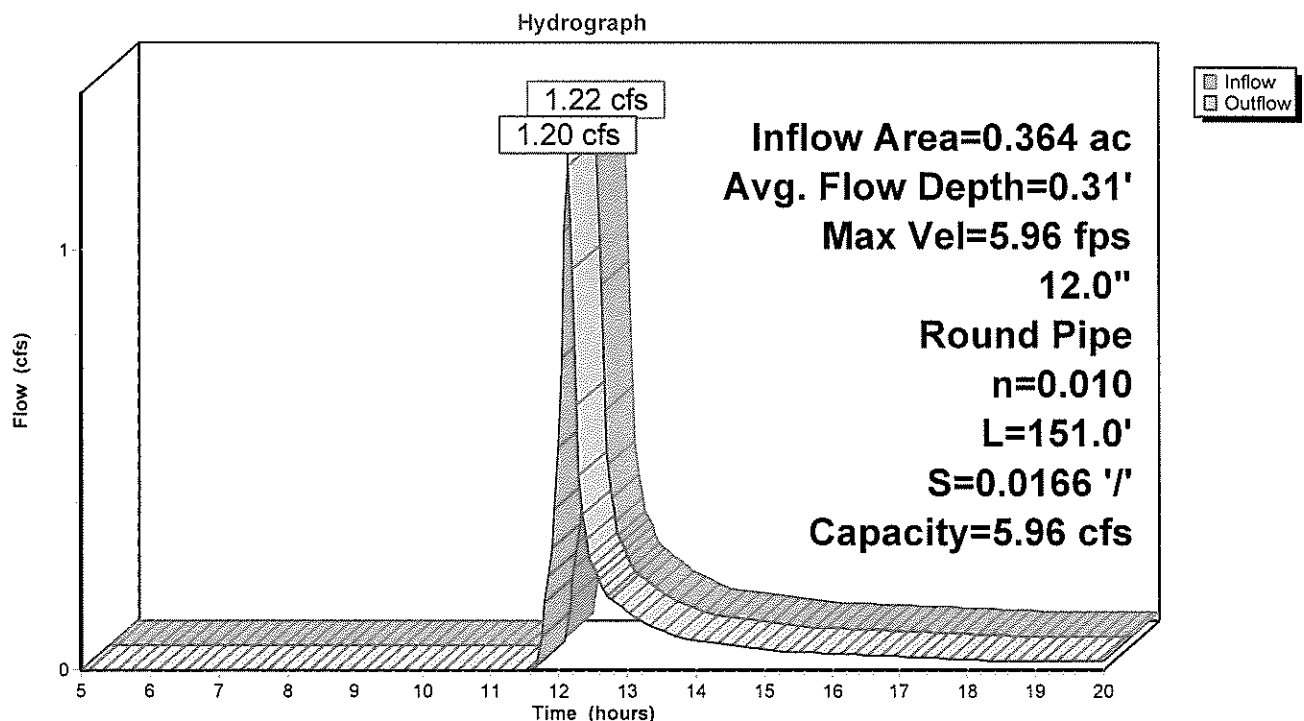
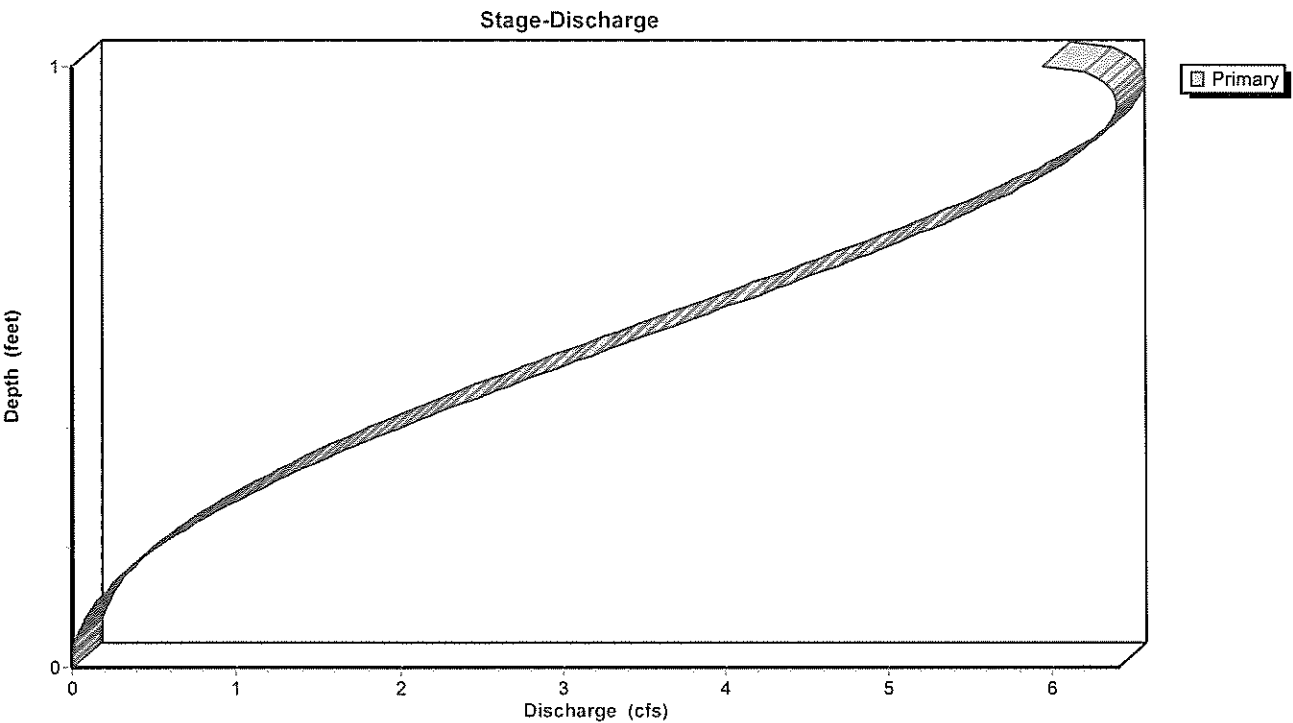
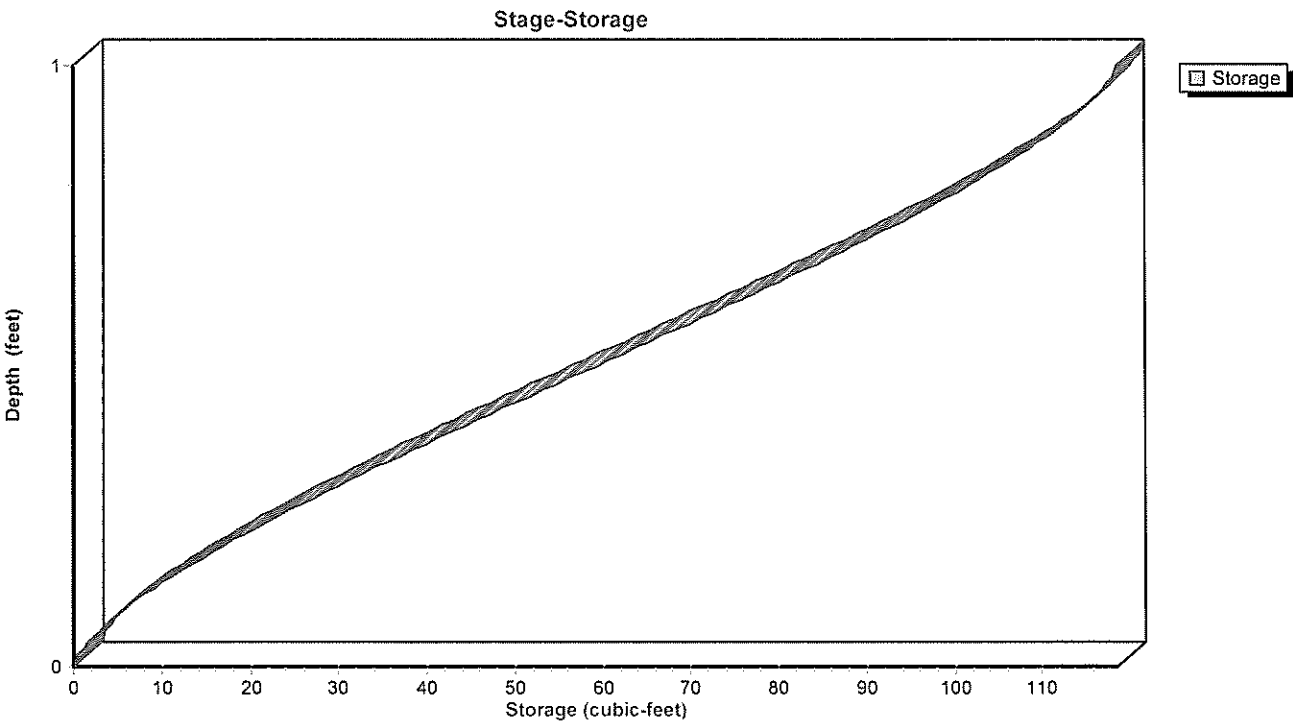
Summary for Reach DL: 12" D PVC Drail Line to CB2 in Millbury Street & Municipal Sewer

Inflow Area = 0.364 ac, 0.00% Impervious, Inflow Depth > 2.13" for 25-Year event
 Inflow = 1.22 cfs @ 12.13 hrs, Volume= 0.065 af
 Outflow = 1.20 cfs @ 12.14 hrs, Volume= 0.065 af, Atten= 2%, Lag= 0.6 min
 Routed to Link CB3 : Design Point - Municipal Catch Basin in Millbury Street
